# Slope failures in the Lavender pit Bisbee, Arizona

(Draft Version)

R W Graeme III

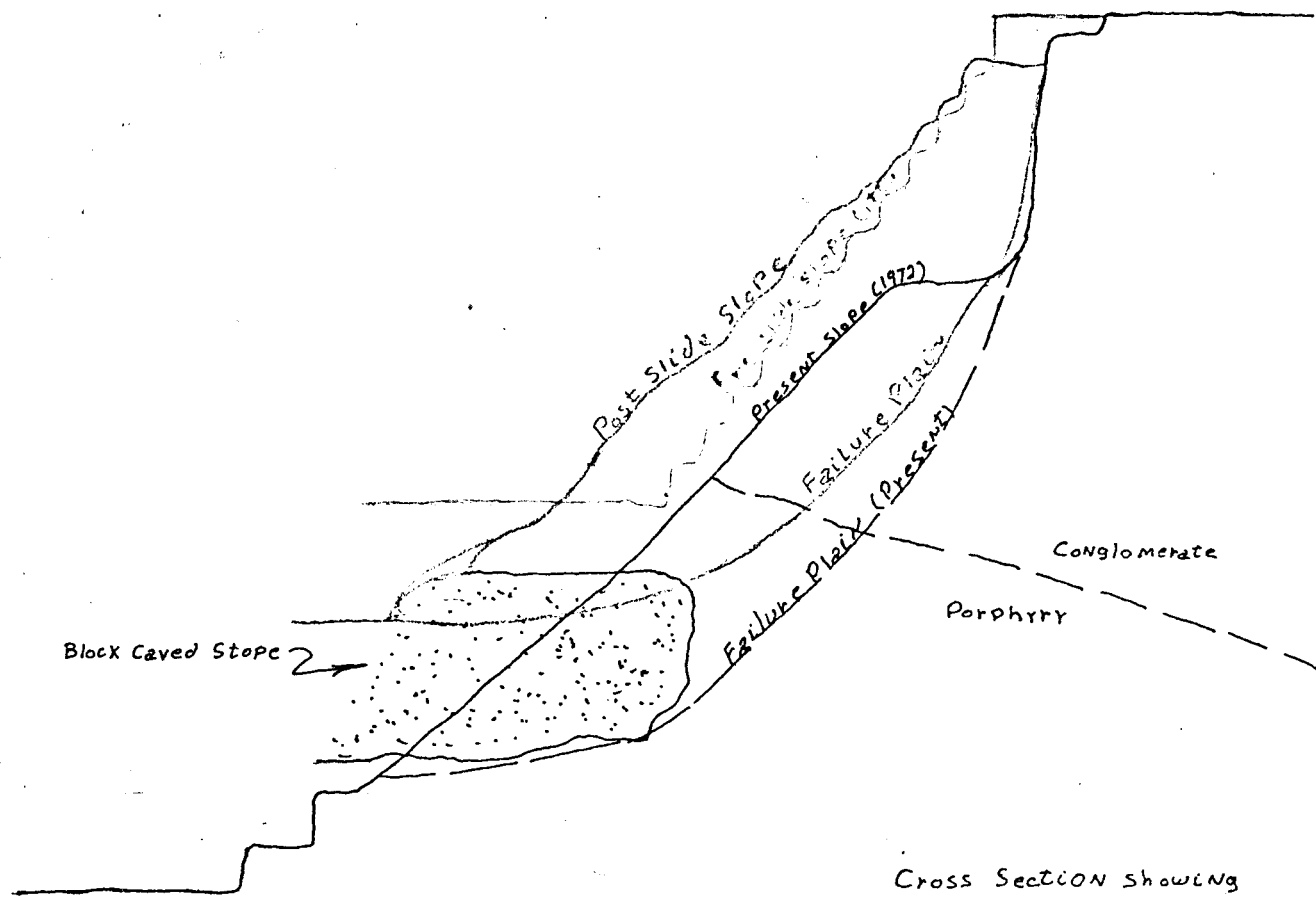
Figure 2

enty-five million tons of broken rock had been displaced about 65 feet below its former level. Movement is still noted in the slide area; however, it is reacting favorably to corrective measures and appears to be stabilizing. A cross-section showing the relative altitude of the slope at different times is given in figure two.

Cross Section showing  
East slope at different  
stages

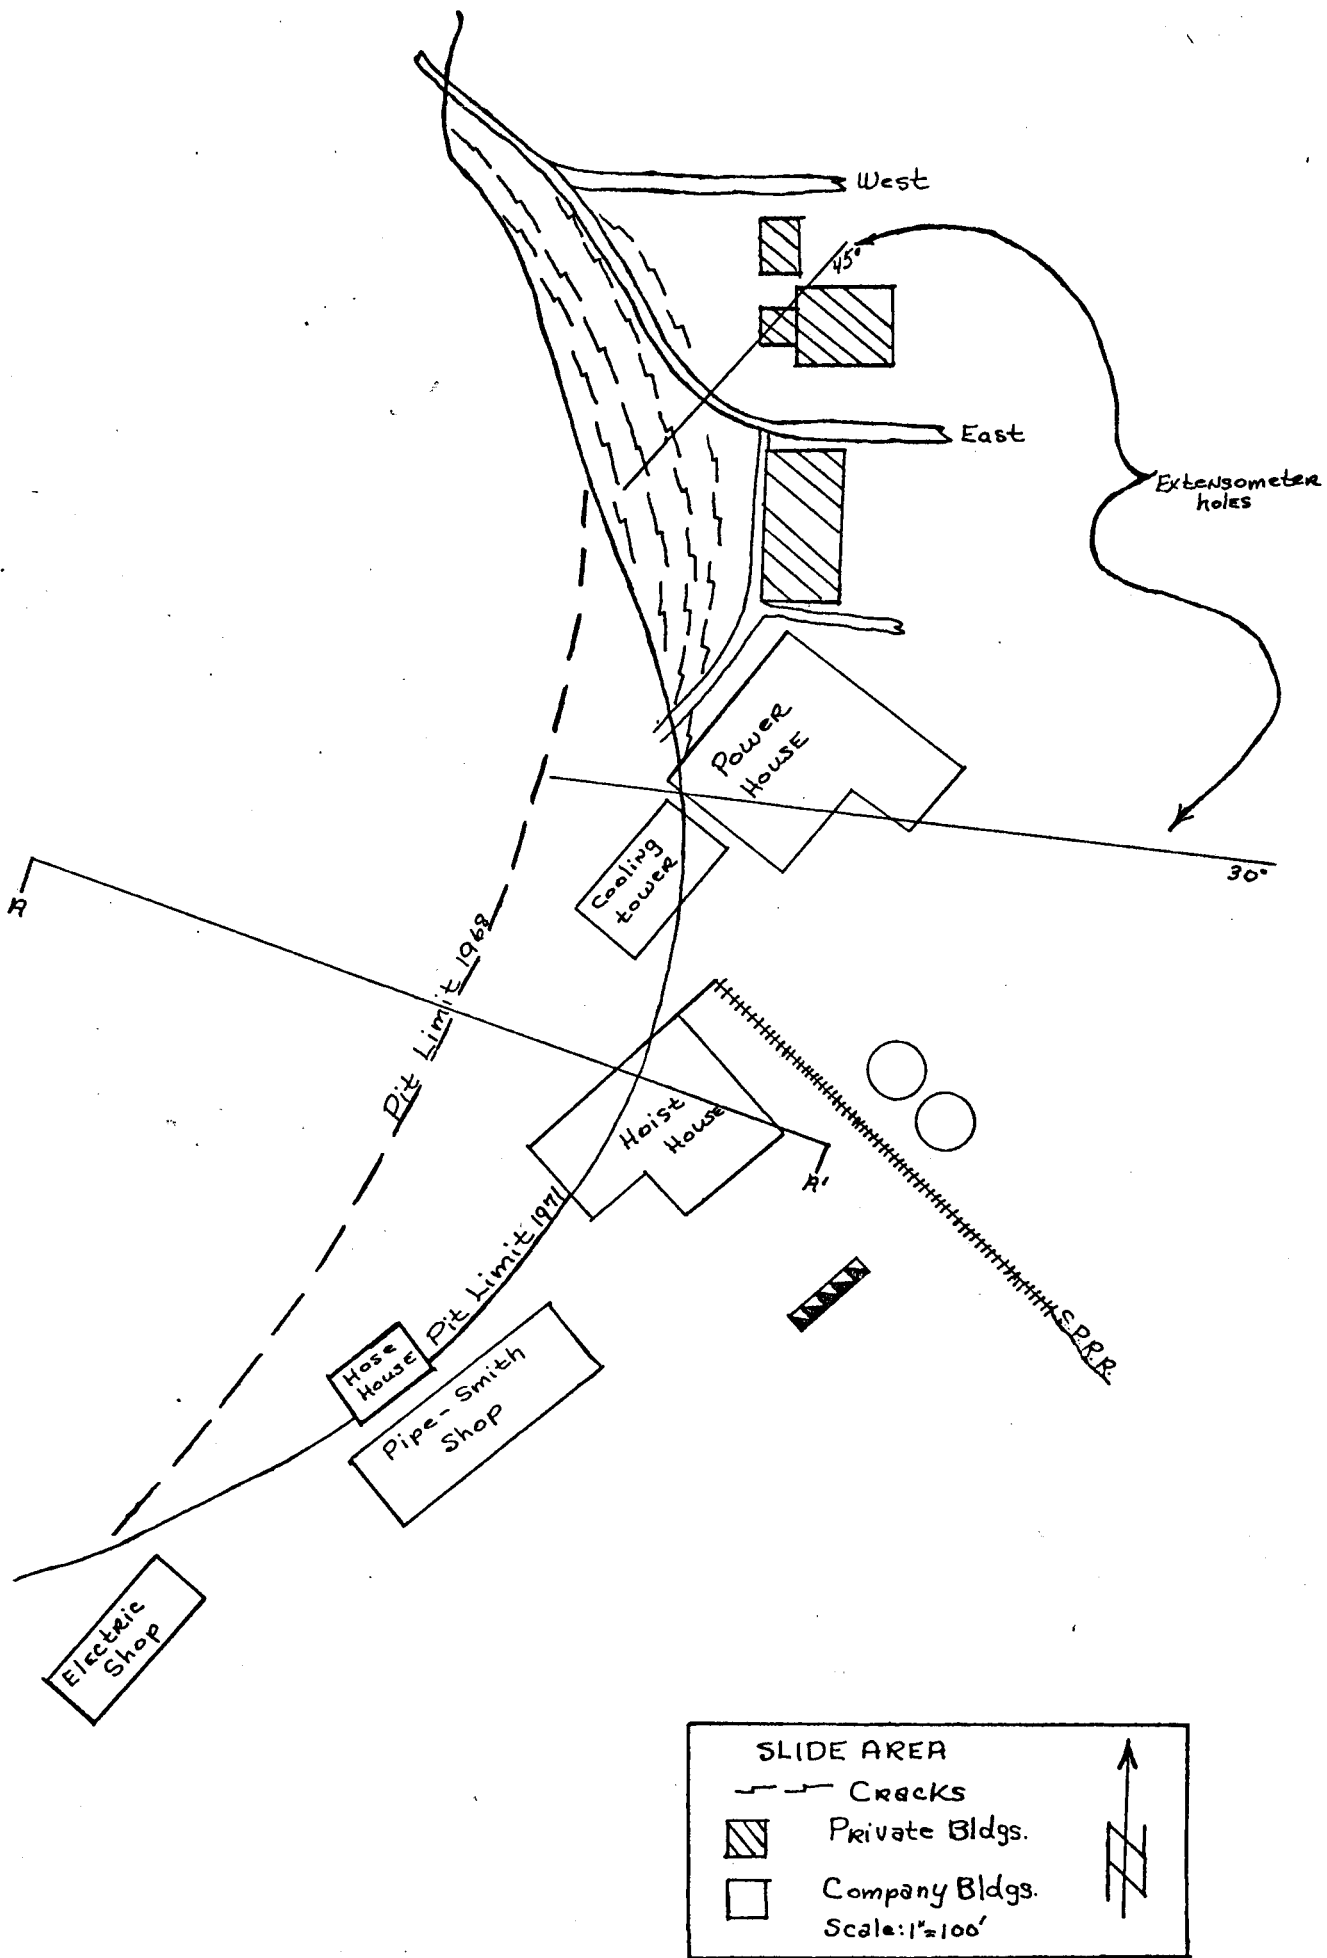
fig. 3

Many cracks appeared in the adjacent community roads and in several brick structures. A U.S. highway suffered a slow displacement of several feet, and only a constant maintenance kept it open, until it was partially re-routed to avoid the potential danger. Before it was over the two remaining hoists for the mine were replaced by smaller more flexible units, the compressors were moved to a new locality at great expense, and floating foundations were put under the four diesel generators. The position of effected features is shown in figure three.

Monitoring was done by the transit-stadia method, until the failure. With increasing danger to the community and mine property as well as continual mining in the bottom, it was evident that a continuous more sensitive monitor was required. One four inch (diameter) rotary drill hole was driven into the slide and an extensometer was inserted. A second was placed under the highway section. These instruments indicate ~~any~~ <sup>slope</sup> movement on gauges and trigger an alarm when an acceleration takes place. The position of these is indicated on figure three.

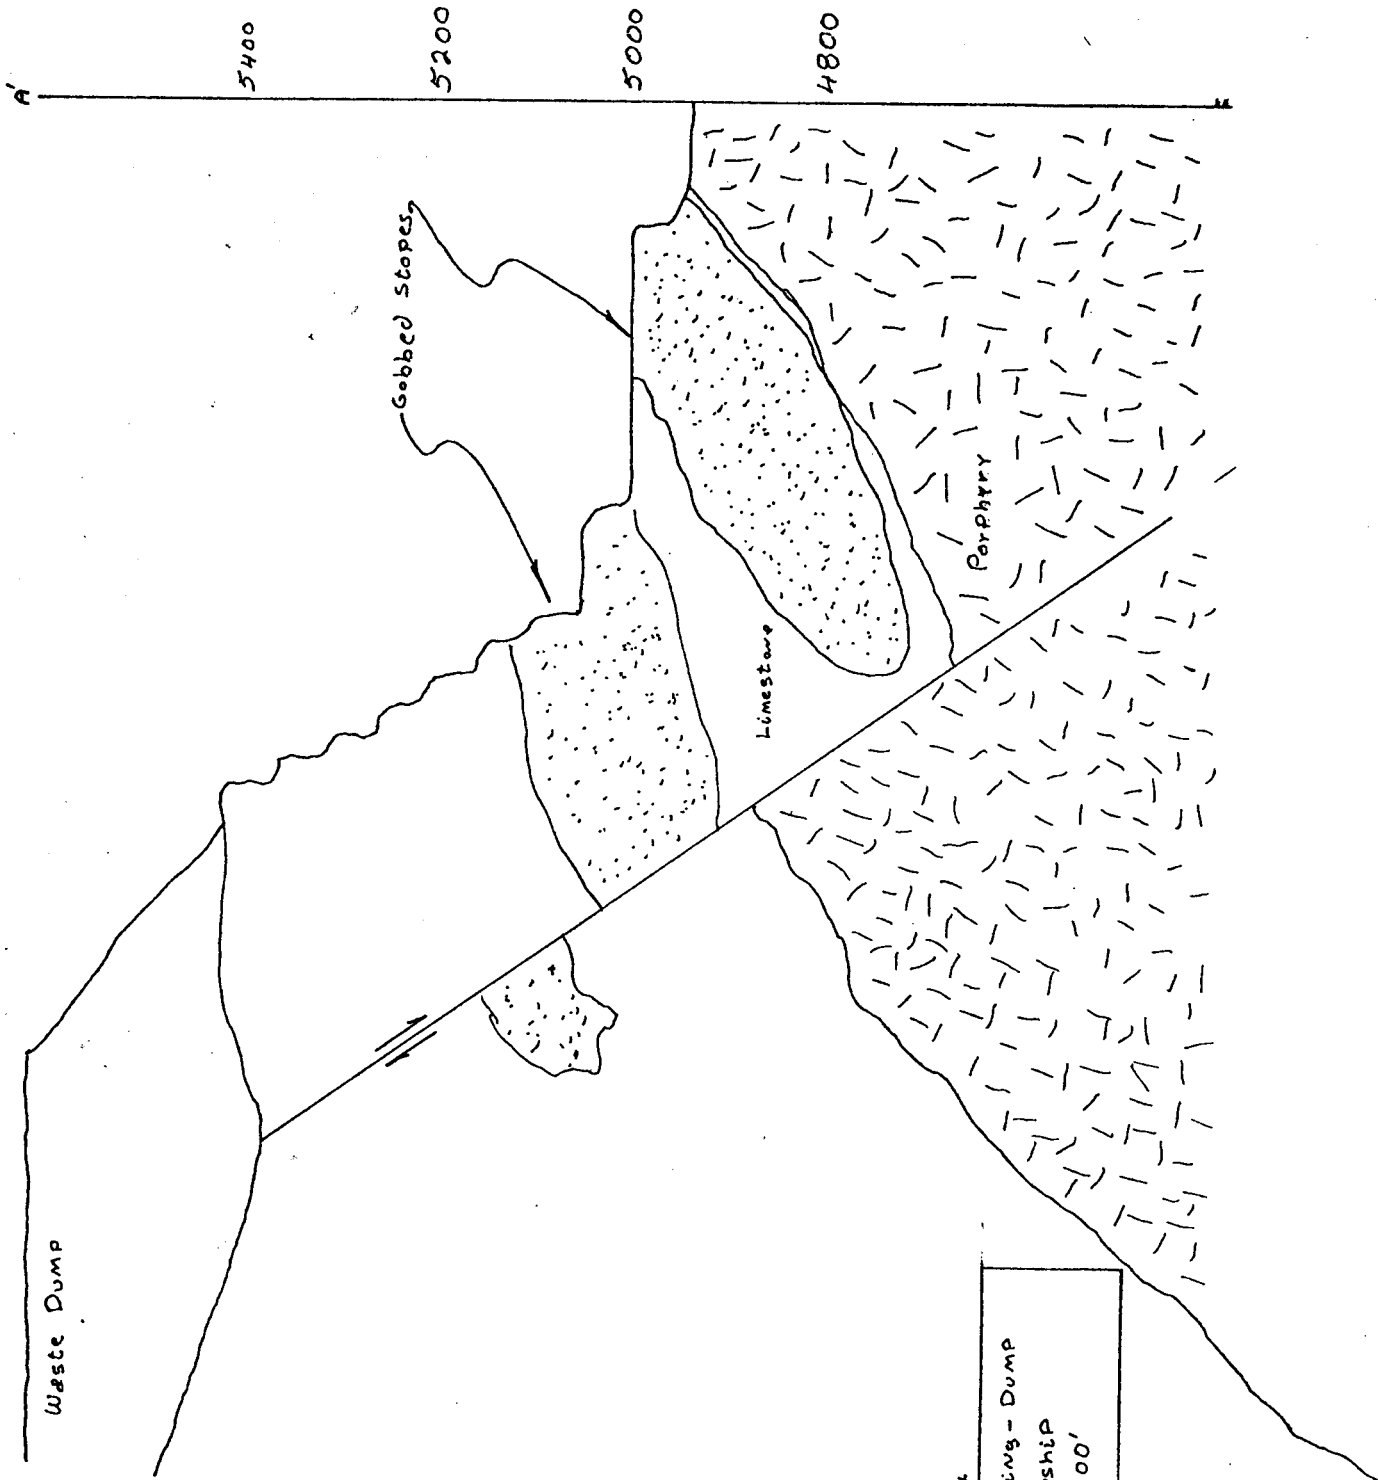
Figure 4  
 Cross Section Showing - Dump  
 Fault, Stopes Relationship  
 Scale: 1" = 200'

The causes of the south slide are a combination of features: two major intersecting structural features, past-underground mining, and mine waste disposal. (Figure four) A north-south and a northeast-southwest fault intersect about 1200 feet from the pit limit, effectively

severing the slide area from the surrounding rock mass. Heavy mining by the cut and fill method near the turn of century removed most of the support from beneath the area. During the development of both the early pit and the present pit, this area was used as a waste dump because of its proximity to the mining area. In some areas the fill is over 225 feet deep. (Figure five) In short, the south section is a dissected, floating, heavily loaded unit with its toe continually being removed by mining. Figure six gives a cross-section of the area.
